MARINE INVESTIGATION REPORT

M99C0003

GROUNDING

**THE BULK CARRIER “PATERSON”
LAC SAINT-FRANÇOIS, QUEBEC**

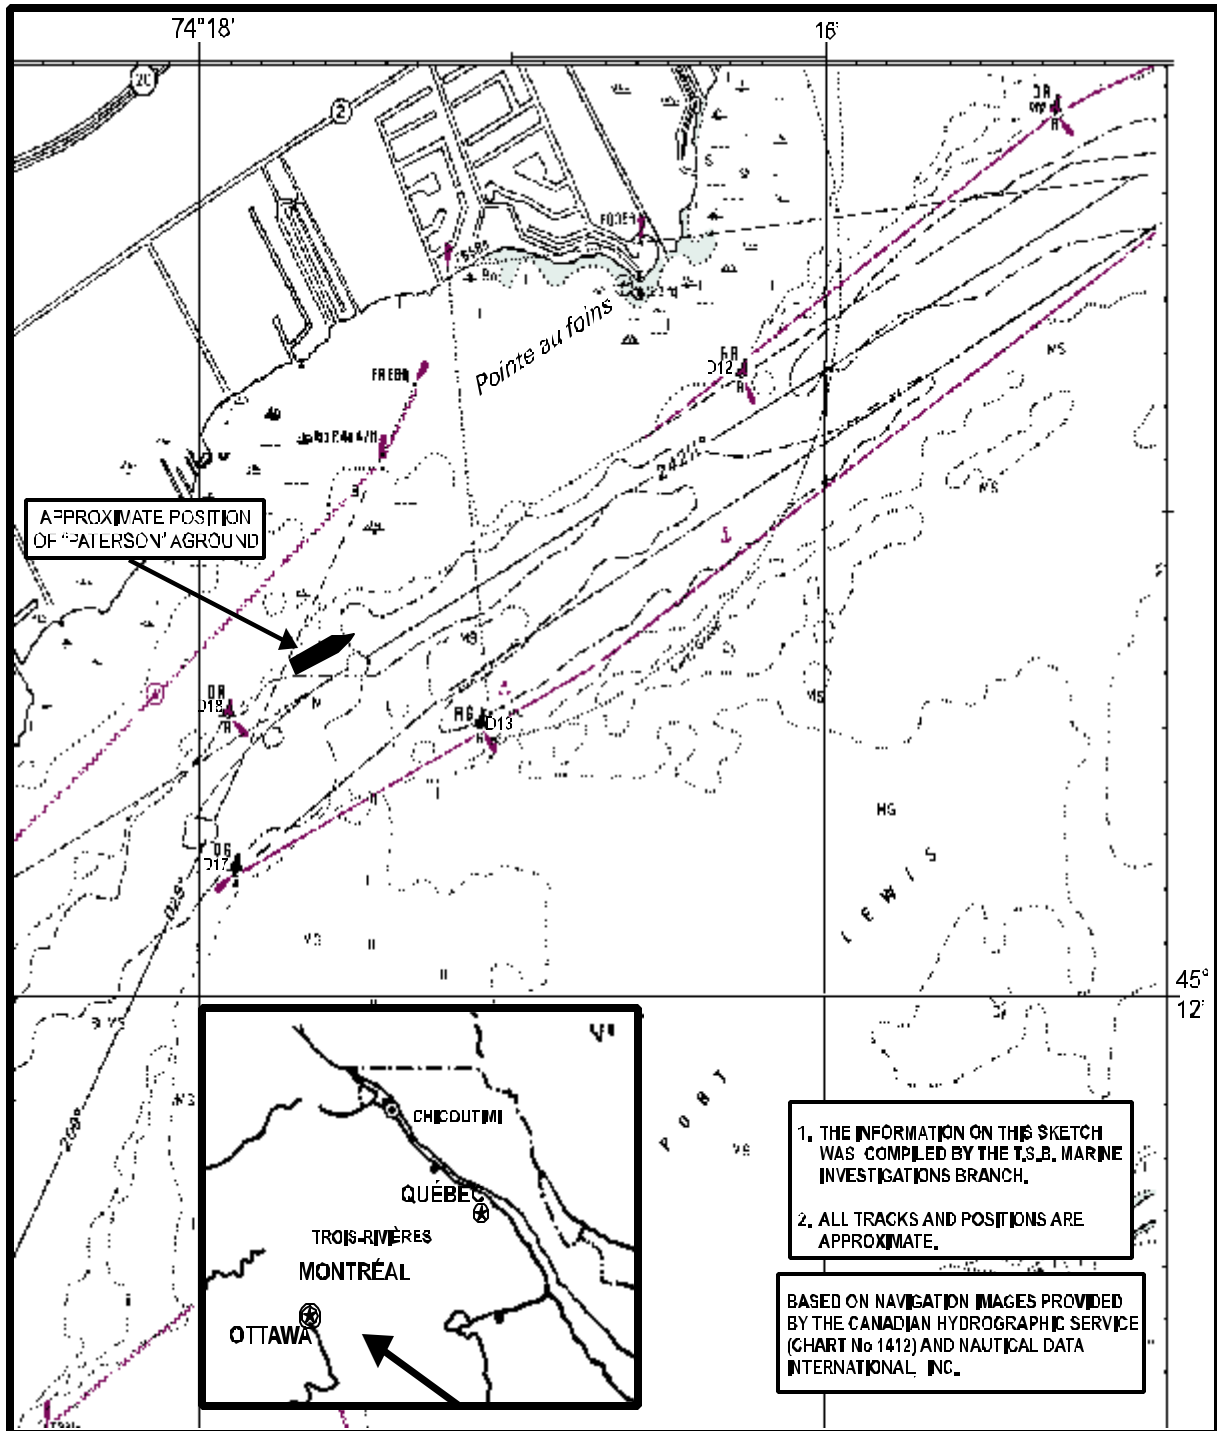
Appendix A - Sketch of Grounding Area

At the time of the occurrence, the "PATERSON" was proceeding at a speed of approximately 11.5 knots over the bottom and experiencing a weak following current of about 0.5 knot. The required thirty-three degree course alteration would produce an advance of approximately 450 m with 30 degrees helm application.³ The maximum room available to the downbound "PATERSON" was about 810 m. By deduction then, the margin of error available, in respect of advance, was about 360 m.⁴ When transferred to a time scale, this is approximately 60 seconds. The result of delaying the course alteration, however, is to correspondingly reduce the margin of error available. In this instance, the margin of error was reduced to approximately 200 m, or about 35 seconds. In other words, the OOW had a window of opportunity of 35 seconds to initiate the (single alteration) manoeuvre. Any delay beyond this in initiating this alteration would result in grounding.

⁴ See Appendix A for illustration of margin of error.

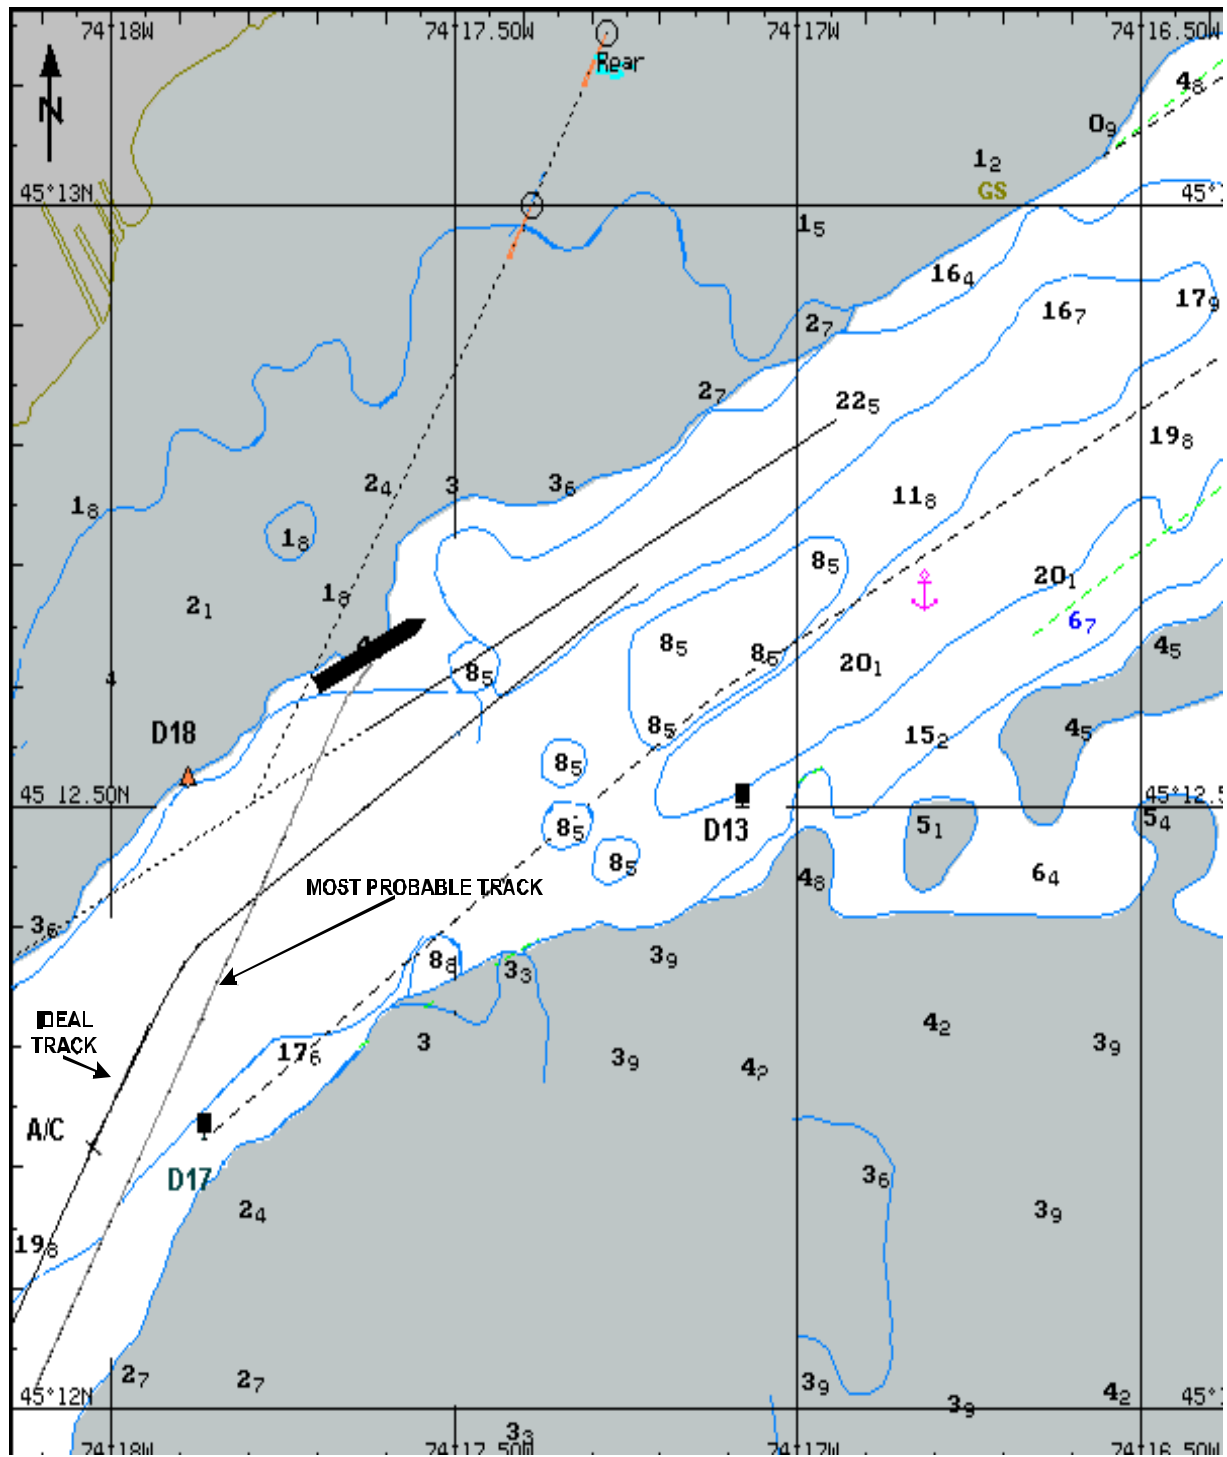
Appendix C - Ideal Track vs. Most Probable Track

11. The turn was delayed beyond the point where, irrespective of the helm used, the vessel could have remained within the navigable channel.
12. The electronic chart system in use did not reflect the appropriate up-to-date corrections, although this is not considered to have been a factor in the occurrence.
